URGENT – MEDICAL DEVICE RECALL FOR PRODUCT CORRECTION

Invacare® TDX® series and Storm Series® power wheelchairs with 20”-24” width configurations with Formula CG Recline seating system (i.e. Tilt/Recline, Tilt/Recline/Elevate, or Recline only) and a conventional style back.

APRIL 28th, 2015

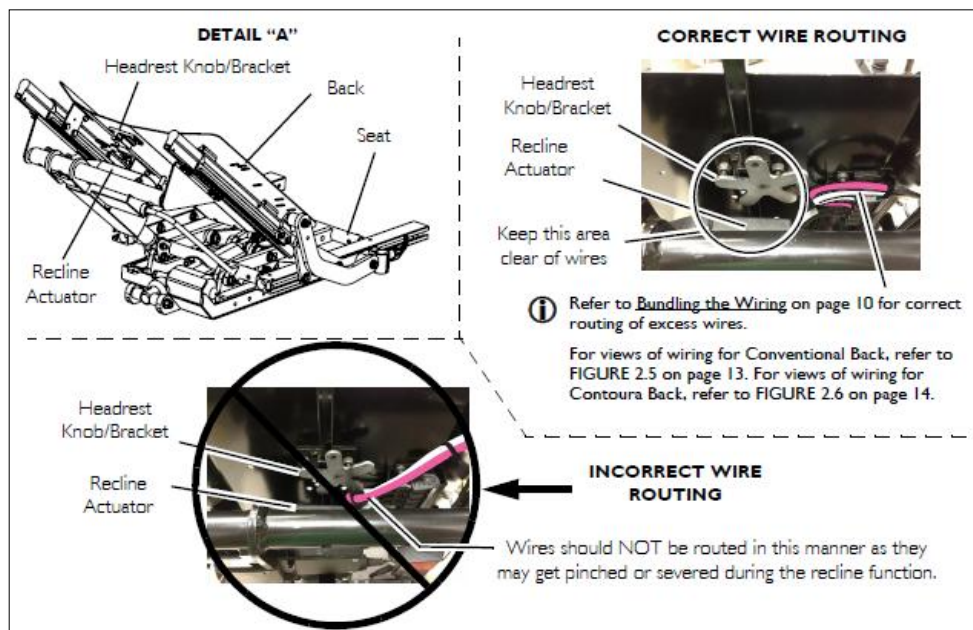
There is a possibility that if the slack in the wires is not routed and secured correctly, and with flexing of the back pan under the user’s weight, the headrest knob or clamp bracket may pinch, damage or cut the wire creating a hazard. Smoking, sparking, burning or fire may occur if any wire in this area is repetitively pinched, at the same location, over a period of time. Not all impacted chairs are expected to have slack in the wiring that is not routed and secured correctly.

1. Please promptly complete and return the enclosed Provider Response Card to Invacare by FAX 1800 814 367 or email to recalls@invacare.com.au to confirm receipt of recall notification and your agreement to conduct it according to instructions.
2. If you have further distributed this product, please identify the power wheelchair owners and notify them at once of this issue and proposed actions. A recommended consumer letter is enclosed for your reference, and should be mailed immediately upon receipt. Please contact your customer to schedule an appointment to inspect the potentially impacted power wheelchair as soon as possible.
3. A visual inspection of the wiring shall be conducted for each impacted chair. The figures below reference correct wiring (page 8 of Power Wheelchair Wiring Guide):

4. Verify that the wiring is routed and secured in accordance with the attached Power Wheelchair Wiring Guide. Invacare expects this inspection to take less than 10 minutes. **If the wiring is not as per the above figure, then the wiring should be corrected as directed in the wiring guide.**
5. Document confirmation of inspection and correction (if required) on the included Unit disposition form and Tracking Sheet and send Upon Invacare's receipt of the Unit disposition form and Tracking Sheet,
6. Invacare will apply a credit to your account for each corrected wiring. If the action is taken at your premises \$ 40.00. If a field action is required \$ 90.00. It is expected the inspection and any correction will take 10 minutes. Please ensure the paperwork is completed to receive the credit your account.
